Immediate Implantation and Alveolar Reconstruction of Compromised Socket

An interesting case of tooth extraction with reconstruction of alveolar bone and immediate implant placement in one visit.

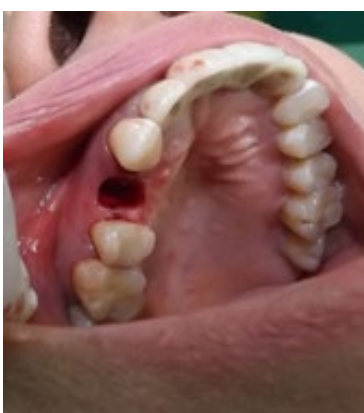
Fig.4

bridge for replacement of the tooth # 14 (with 2 wings on #13 and # 15) immediately after the extraction. Later on; extraction of the tooth, a good enucleation of the soft tissue in the periapical area of the socket, and checking of the labial plate were done. There was labial bone loss at the middle third of the root (Fig. 4).

The post extraction pictures showed that there was no labial bone

and we needed to reconstruct this bone after placement of the implant, in order to give better stability and osteo-integration for our future implant, as well as for esthetic reasons.

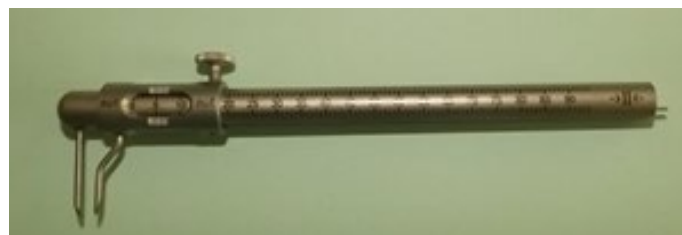
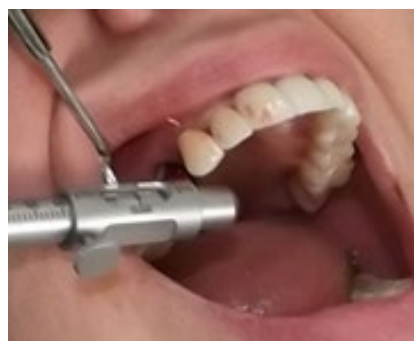
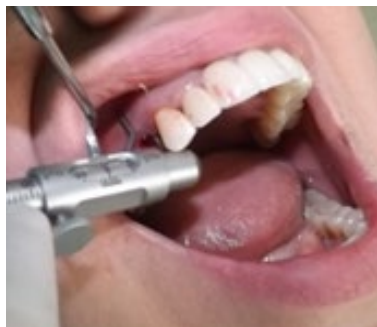
We used a special device to determine the amount of bone present there and the diameter of the socket (Fig. 5, 6 and 7). These measures helped us to decide which size of implant we should use

and the areas of bone loss.

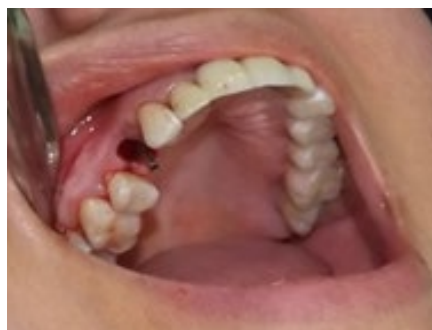
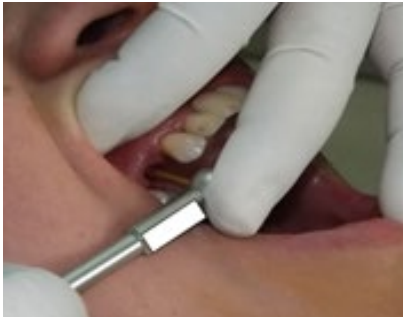
We started to do the pilot drill inside the socket, initially vertical

and then with an angulation of 15 degrees palatally, in order to use the palatal bone and get primary stability because there was a deficient labial plate (Fig. 8, 9, 10 and 11).

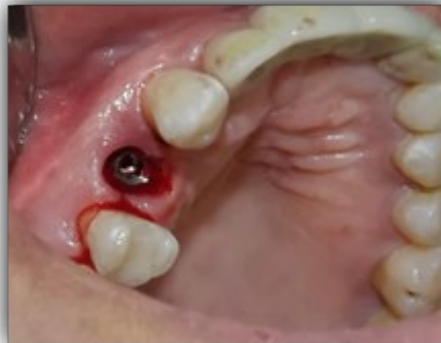
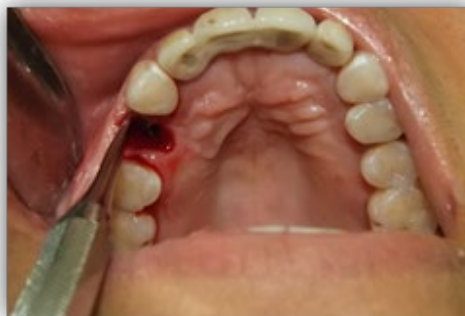
The placement of the implant went perfect and we got primary stability, however, there was a space between the implant and the labial soft tissue (Fig. 12 and 13). So, we decided to do bone

grafting and augmentation into the area.

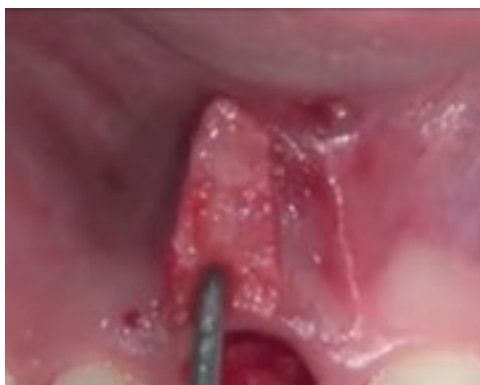
Fig 19

#18, which needed to be extracted (Fig.14 and 15). After anesthesia and removal of the impacted tooth, we used the labial bone that covered it, as a graft for the missing alveolar plate in our socket (Fig. 16, 17 and 18). The autogenous bone was shaped according to the missing alveolar plates and was placed buccally

to the implant (between the implant and the periosteum), which represents the future alveolar plate (Fig. 19). We also got some chips of spongy bone from the extraction area along with bovine bone which, mixed together and placed in the empty space

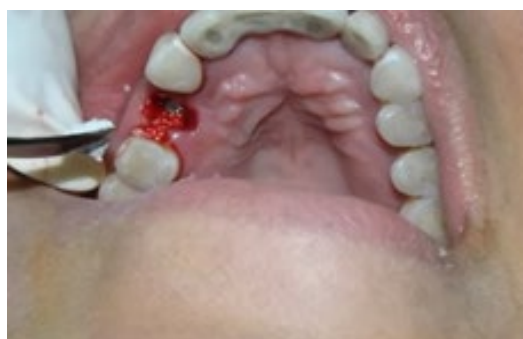
Fig 20

(Fig. 20).

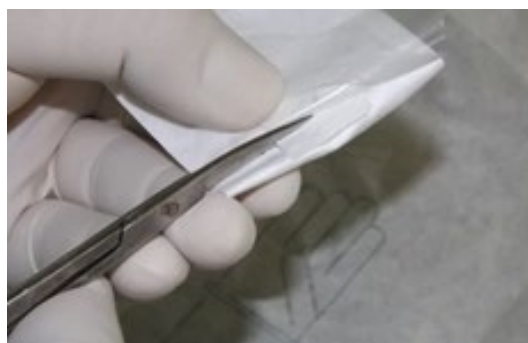
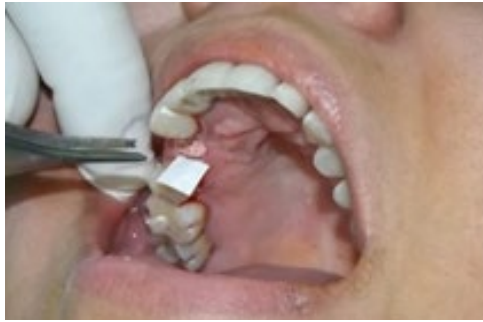
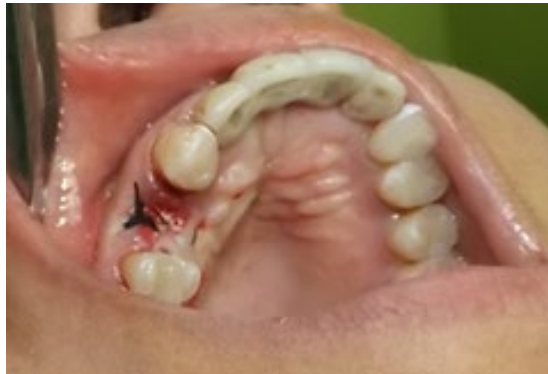
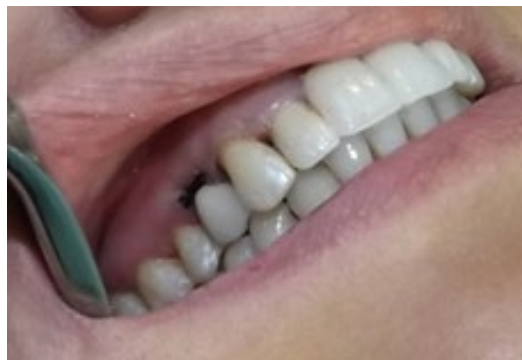
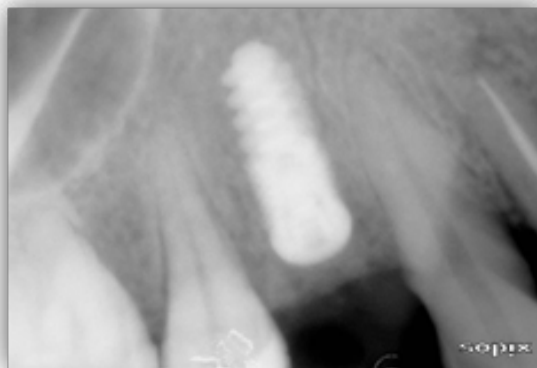
Finally, we covered that bone by Jason pericardium membrane, we sutured the area with 3/0 black silk suture and we placed the Maryland bridge immediately after the intervention (Fig. 21, 22,

23, 24 and 25)

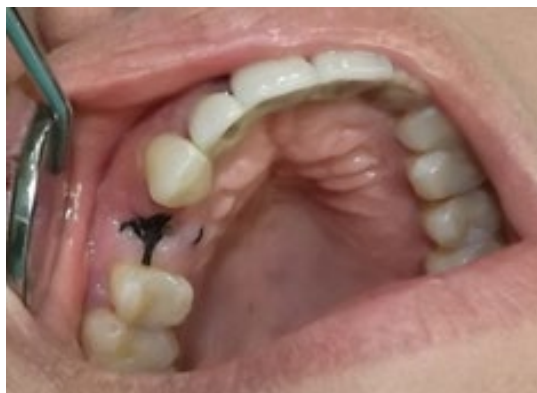
Fig. 26

One week later, the sutures removed and the area irrigated and cleaned (Fig. 26).

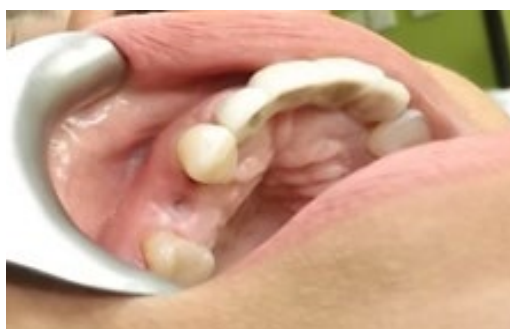
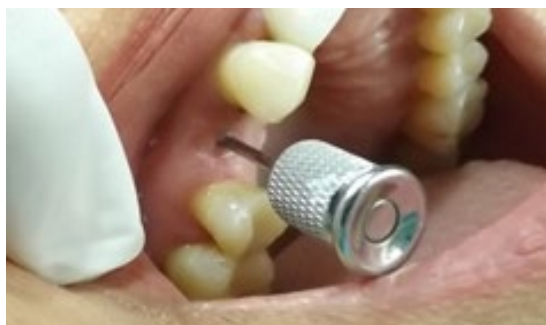
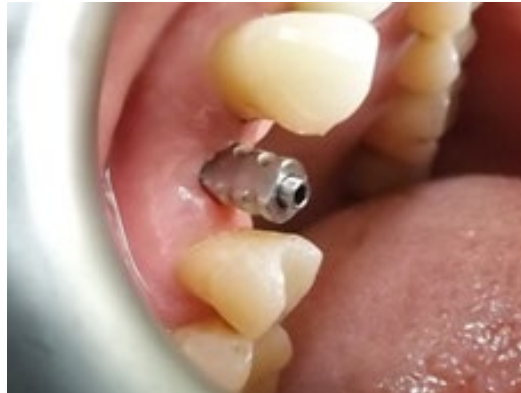
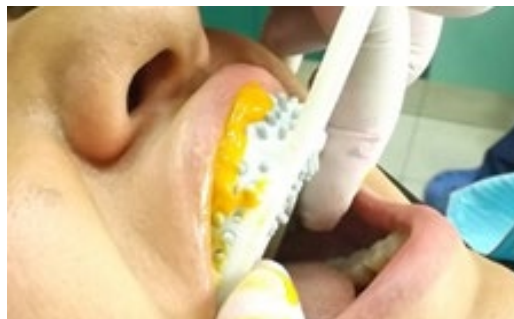
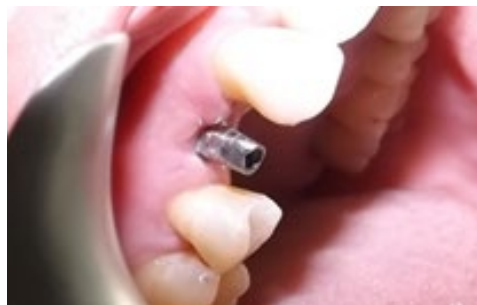
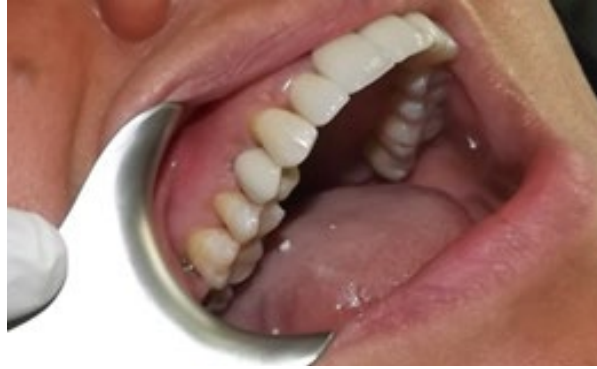
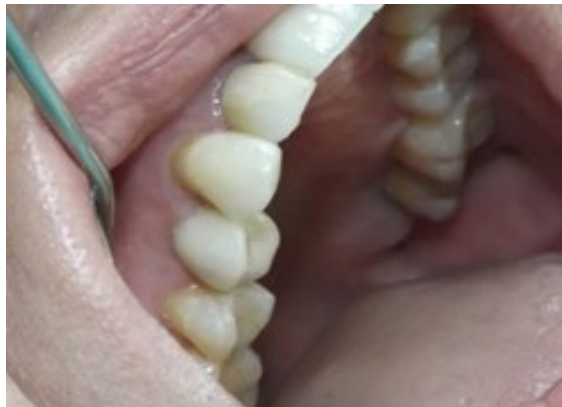
weeks (3 months). And after 3 months we continued the prosthetic protocol for the placement of the final prosthesis (Fig. 27, 28, 29,

30, 31, 32, 33, 34 and 35).
